Manhole Inspection Summary

Manhole # S290__001MH

Insp Date: **4/13/09 11:28 AM**

Location Address: **W CROSS ST**

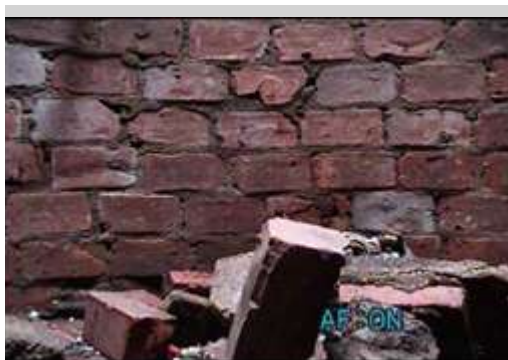
Miscellaneous

bench debris

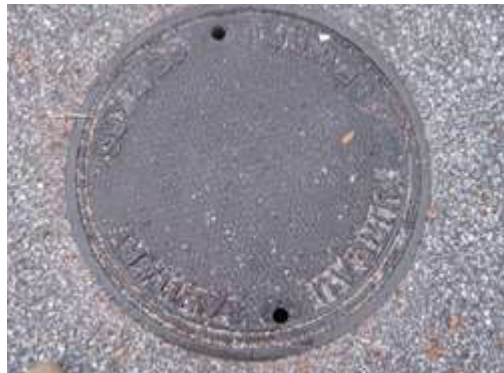
Miscellaneous

COVER PIC

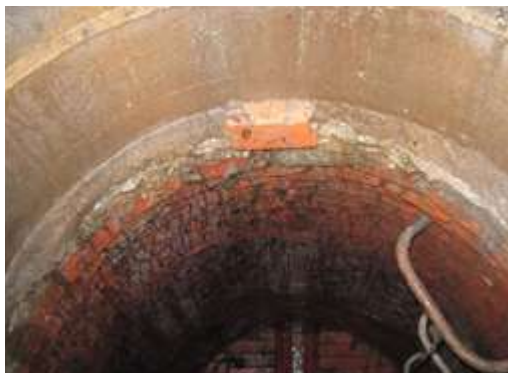
Defect 1

Frame Offset: **0** (in.) Condition: ☐ Sound ☐ Cracked ☒ **Leaks**

LID/FRAINFILTRATION

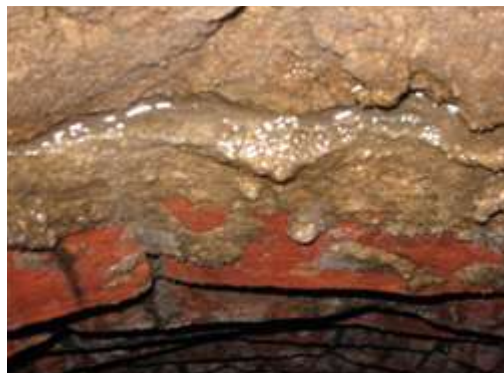
Defect 2

Infiltration: ☐ None ☒ **Joint** ☐ Cracks ☐ Mortar ☐ Roots ☐ Wall

JOINT FRAME/CHIMNEY INFILTRATION

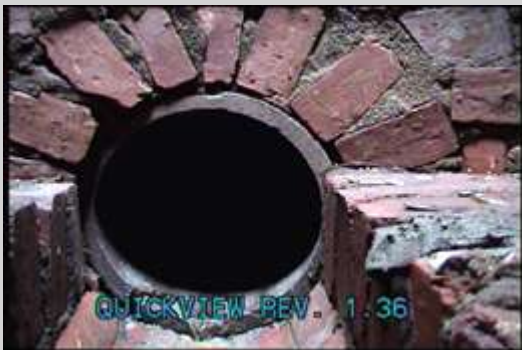
12 O'Clock Outflow

8 in. Circular Gravity Sewer
Pipe Out @ 12 O'Clock

Pipe Height: **8.4** (in.) Rod and Bar (Angled)
Pipe Material: **Clay** ☐ Pipe Lined
Invert Depth: **9.08** (ft.) Flow Characteristics: **Slow**
Deposits: ☒ None ☐ Mud ☐ Sludge ☐ Debris ☐ Grease
Silt Depth: **0** (in.) Deposits Extent:
Infiltration: **None** Pipe Seal Cond: **Sound**

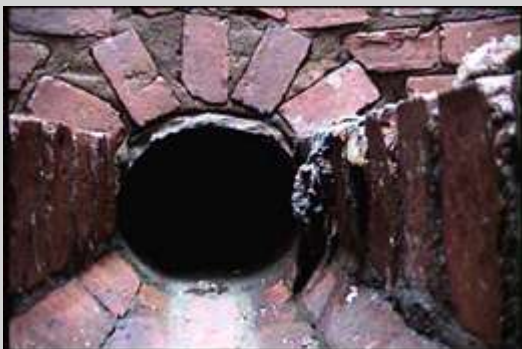
6 O'Clock Inflow

8 in. Circular Gravity Sewer
Pipe In @ 6 O'Clock

Pipe Height: **8.4** (in.) Rod and Bar (Angled)
Pipe Material: **Clay** ☐ Pipe Lined
Invert Depth: **8.56** (ft.) Flow Characteristics: **Slow**
Deposits: ☒ None ☐ Mud ☐ Sludge ☐ Debris ☐ Grease
Silt Depth: **0** (in.) Deposits Extent:
Infiltration: **None** Pipe Seal Cond: **Sound**
